REMOVAL SITE EVALUATION K-65 SILOS
RADON TREATMENT SYSTEM

**REMOVAL SITE EVALUATION
K-65 SILOS RADON TREATMENT SYSTEM**

**Fernald Environmental Management Project
(FEMP)
Fernald, Ohio**

January 1992

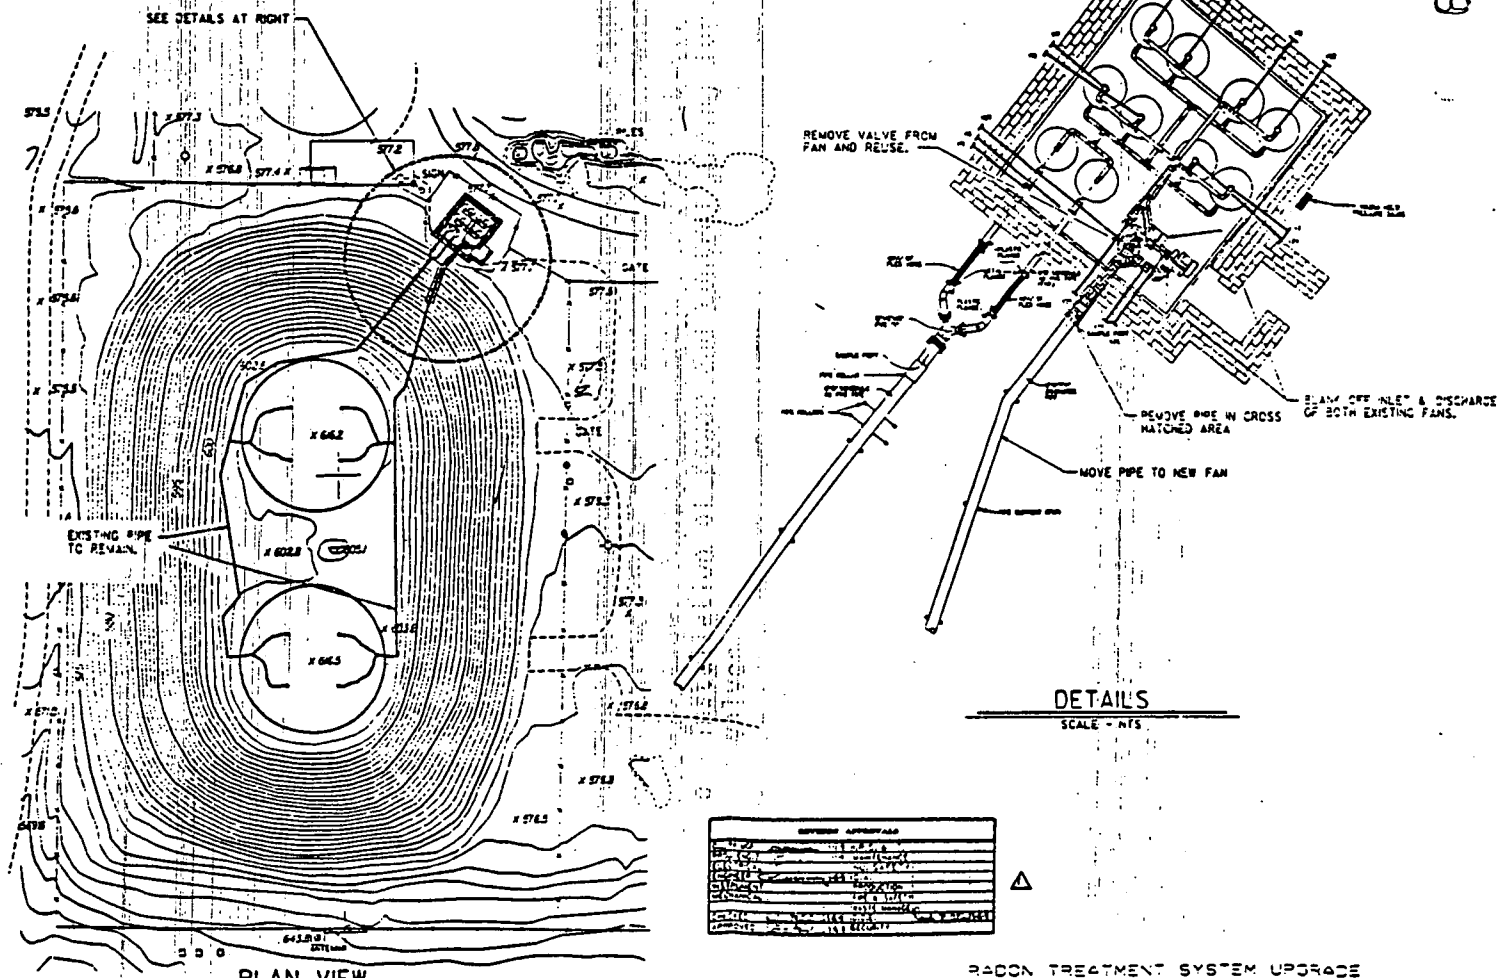
FIGURE 1-2. RADON TREATMENT SYSTEM

Figure 1-2 illustrates the basic components of the RTS. The RTS was originally designed to be used on each K-65 Silo separately. This design assumed a system airflow of 1,000 ft³/min., an initial radon curie content in the air space above the residues of 37 Ci and a one-time, 10-volume turnover for each silo. It was estimated that at least 0.4 Ci of radon remained in the silos after treatment because of perpetual generation of radon. The controlling criterion for the RTS operation was based on gamma radiation exposure rates at the silo dome surface rather than the radon concentration within the silos.

In March 1990, a cracked tee pipe in the RTS unit was discovered and attributed to poor design and selection of materials. The piping failure was the result of degradation brought on by ultraviolet radiation, cold temperature embrittlement, thermal stress and severe stress that resulted from lateral movement against a rigid PVC tee. This incident prompted an investigation concerning further operation of the RTS unit. The investigative committee's recommendations were addressed and the system was next operated to support content sampling from October through December of 1990.

A decision was made that the system should be upgraded prior to any further operation. This upgrade included the following actions:

- o installation of a new higher static fan outside the RTS building
- o installation of new remote-controlled gas tight butterfly valves
- o construction of manhole extensions with permanent RTS ports provided for the eight peripheral manholes in the K-65 silos
- o installation of power and control wiring for the fan and PVC piping valves
- o pressure testing of the RTS unit to ensure piping integrity
